## Fearon Hall Loughborough

### Underpinning/ Ground Stabilisation

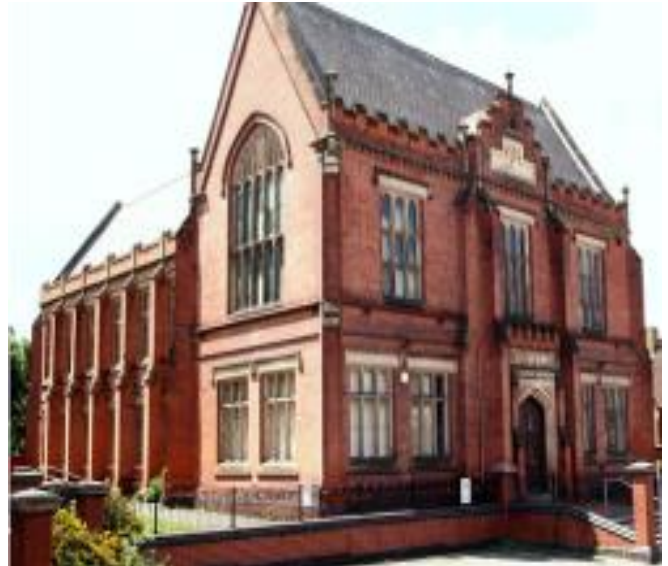
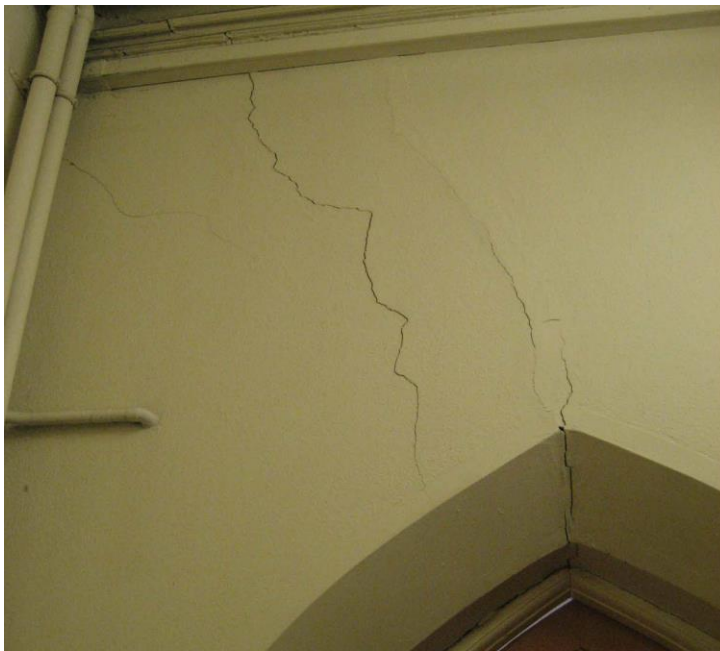
Structurally the original hall showed no signs of distress or undue movement, however the newer front section had a significant problem in the North East corner with settlement and cracking.

Given the visible opening up of the movement joint and recent nature of the cracking within the Paget Room it is clear that the measures taken had not addressed the cause of the settlement and that ongoing movement is occurring.

The structural underpinning that was required at Fearon Hall meant we had to carry out resin injections to the North and East external walls and to all four walls of the basement.

The injection consolidates the ground beneath the foundation approximately 4-5 metres below ground level.

The consolidation generated a safe ground bearing pressure at the underside of the foundation.

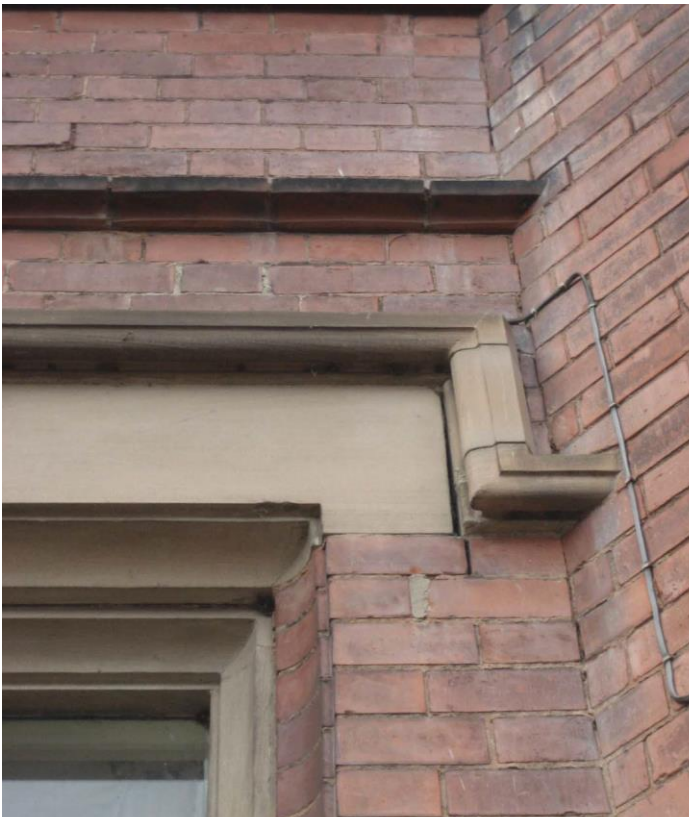
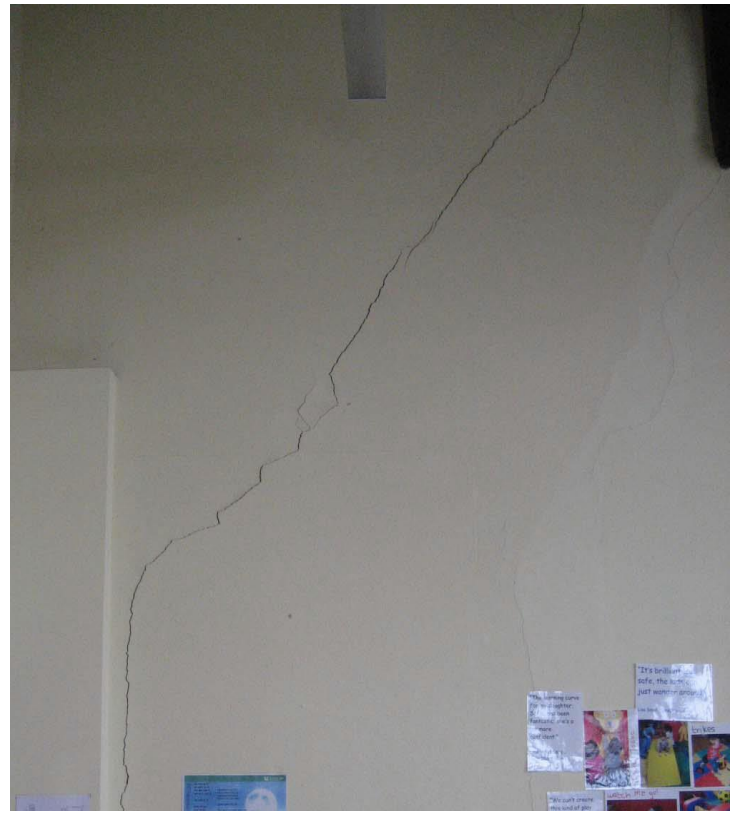
As the images show there was also a lot of damage to the inside of the Fearon Hall due to the movement of the building.

We found that the areas requiring structural repair could be repaired by helical stitching. The stitching bars and anchors provided a permanent solution for the masonry repairs and crack reinforcement.

We used this method as our stainless-steel brick ties and anchors have a tensile strength within the 1050-1200N/mm<sup>2</sup> band and a spiral twist that permits a degree of torsional yield within its elastic limits. Anchored across the fractures, the helical stitching ties progressively accumulated building loads and disperses them back into the structure to strengthen cracked walls.

Internally, the first-floor pageant room had a lot of cracking. We solved the cracks by raking out and filling the cracks with an epoxy repair mortar. We then as an addition plastered the walls before redecorating them with emulsion back to their original colour scheme.
